New York State Department of Transportation

Red Flag NB2358W008

BIN: 1065318

Location: Span 30, Stringer S1 at Pier 30 above the sidewalk at the intersection of 65th Street WB roadway and 4th Avenue.

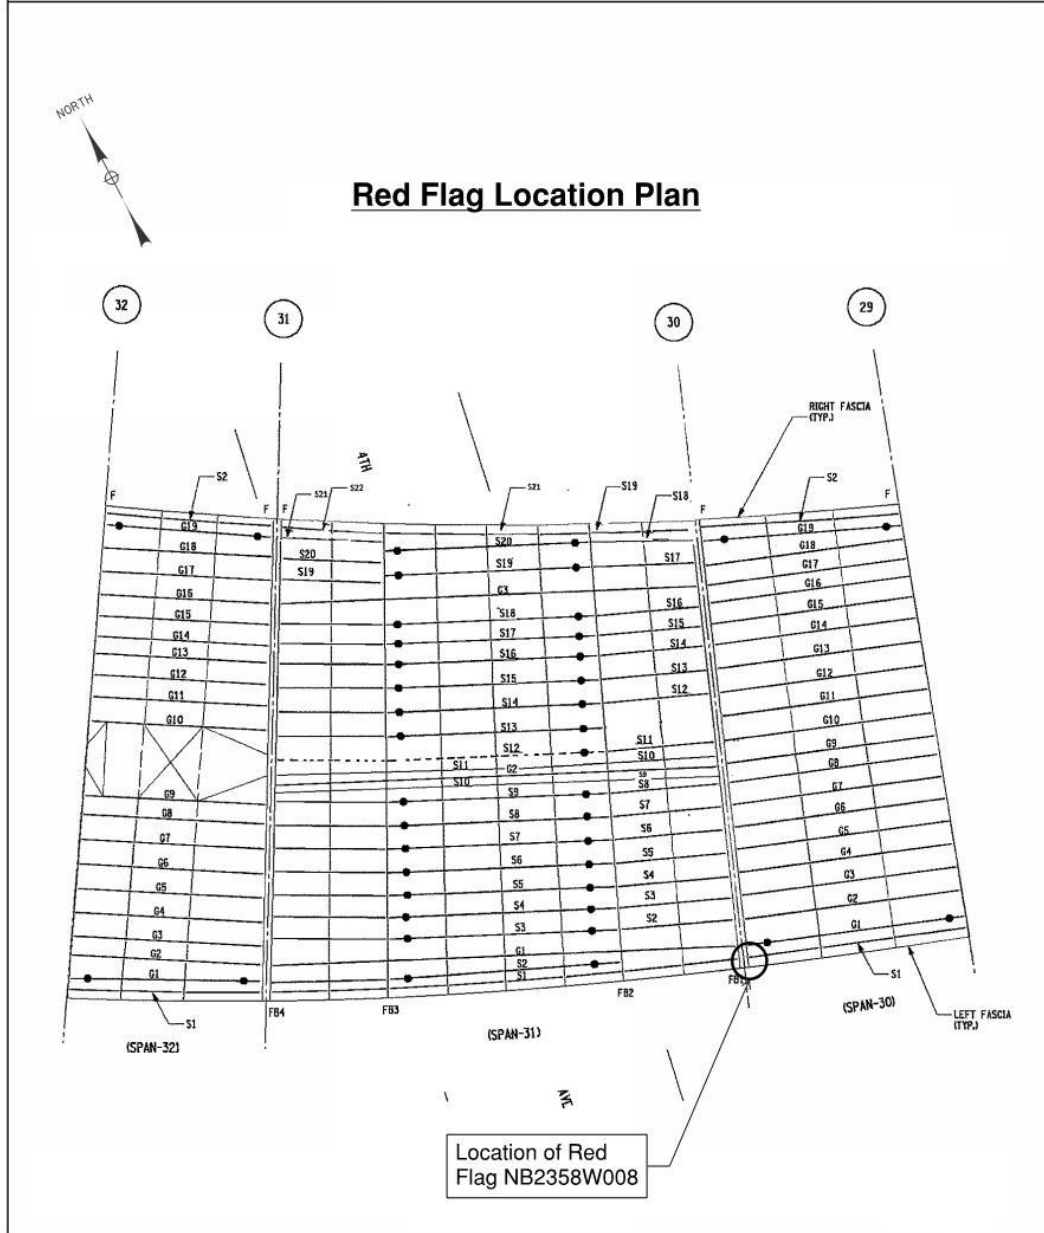
Photo Number: 2

**Attachment Description: Flag Location Plan**

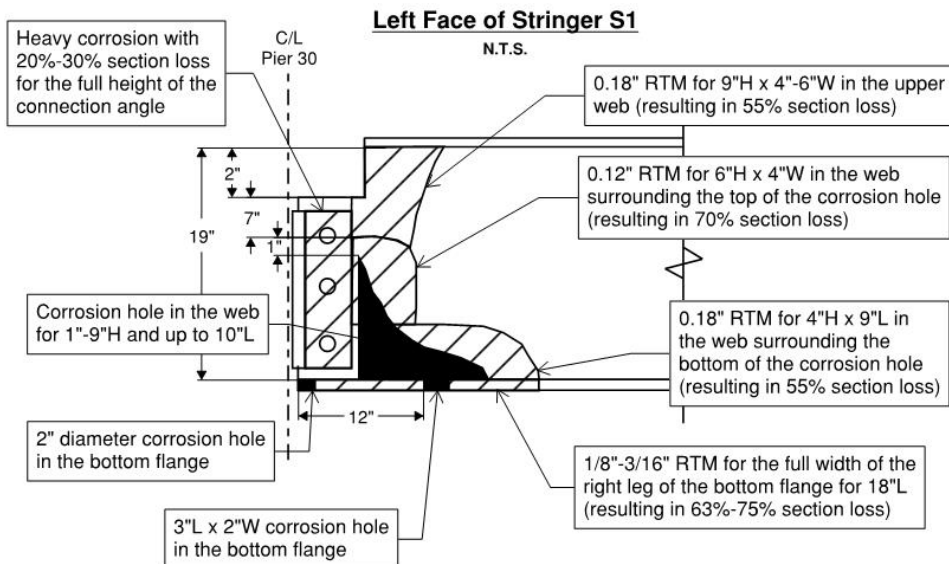
Photo Number: 3

**Section Loss Calculations:**As-built shear web area = $0.40" \times 17" = 6.8 \text{ in}^2$ Shear web section loss area = $0" \times 9"H + 0.12" \times 1"H + 0.18" \times 7"H = 1.38 \text{ in}^2$
(calculated at the highest point of the corrosion hole for 9"H below the top cope)Overall shear web section loss = $(6.8 \text{ in}^2 - 1.38 \text{ in}^2) / 6.8 \text{ in}^2 = 80\%$ **Notes:**

- The right side bottom flange exhibits similar section loss as shown above with 1" diameter corrosion hole in the bottom flange approximately 15" from the stringer end.
- The as-built field measured stringer web thickness is approximately 0.40".
- The as-built field measured stringer flange thickness is approximately 0.50".
- The stringer is a segmental stringer framed into the pier capbeam at one end and framed into ID2 at the other end of the stringer.

Attachment Description: Flag Condition Sketch

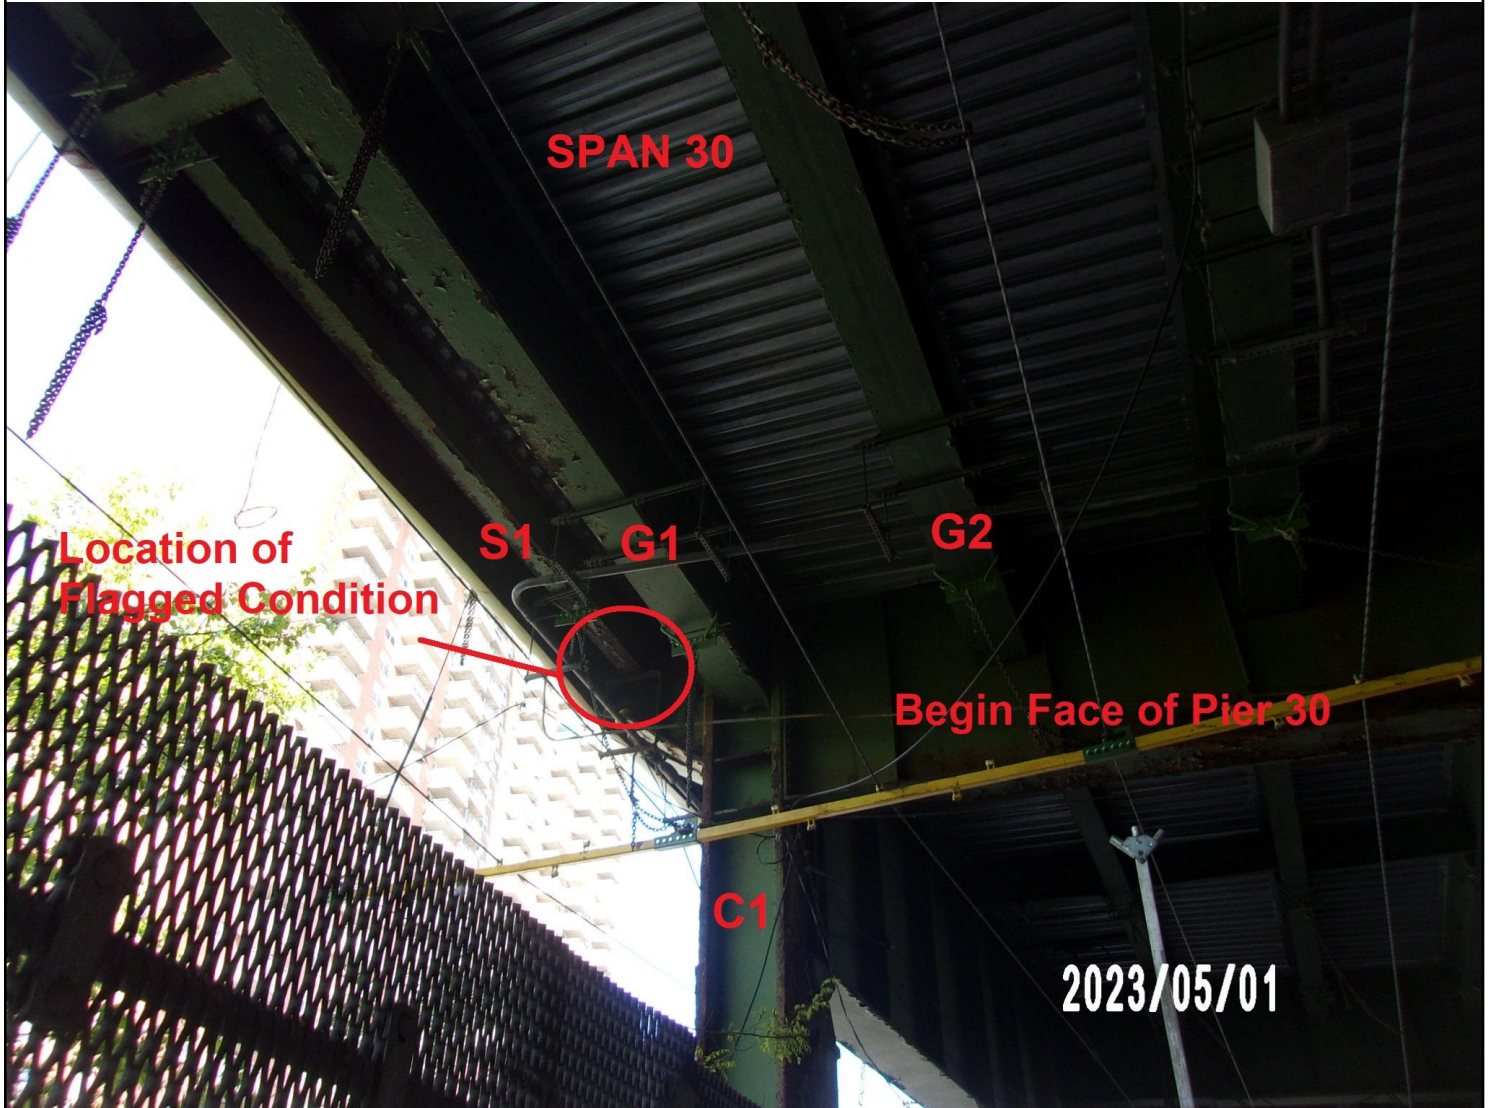
Attachment Description: General view of the flagged condition at Stringer S1 in Span 30 at Pier 30. Looking End.

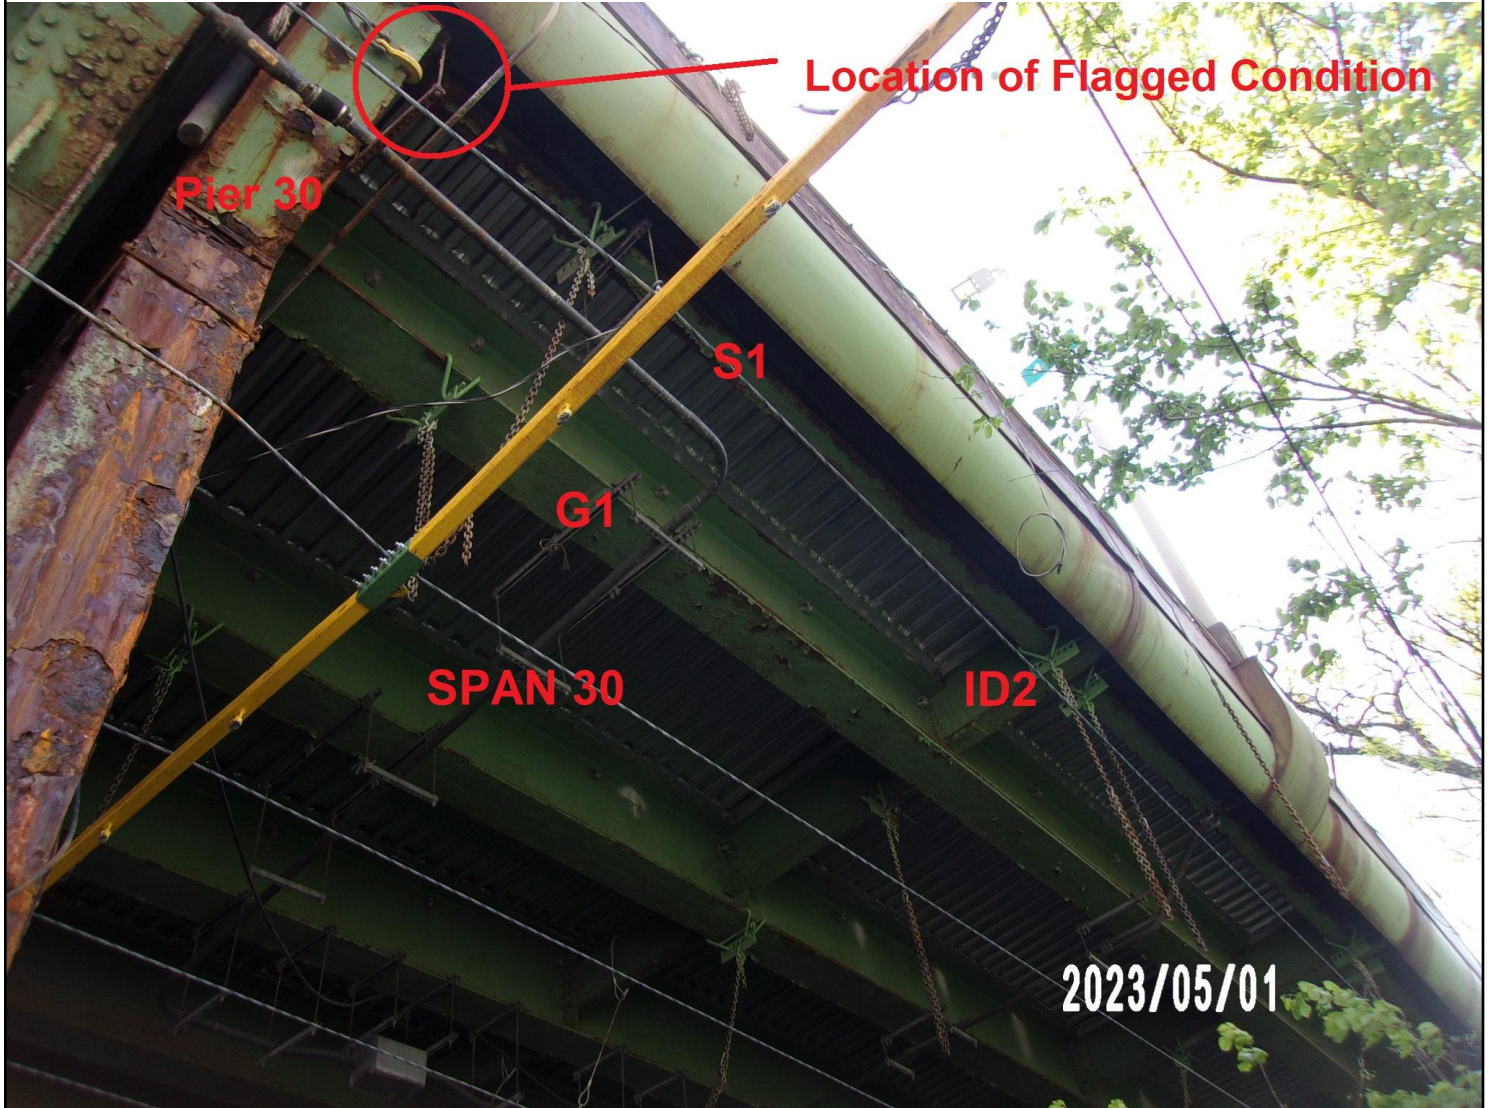
Photo Number: 4

2. The flagged stringer is a segmental stringer which is framed into the pier capbeam at one end and framed into intermediate diaphragm #2 (ID2) at the other end of the stringer (ID2 is framed into the web of Girder G1). (Photo #4) The Stringer S1 connection to ID2 exhibits no significant defects. Also, the stringer end at Pier 30 is located above Column C1.

Attachment Description: General view of the flagged condition at the segmental Stringer S1 in Span 30 at Pier 30. Looking Begin and Right.

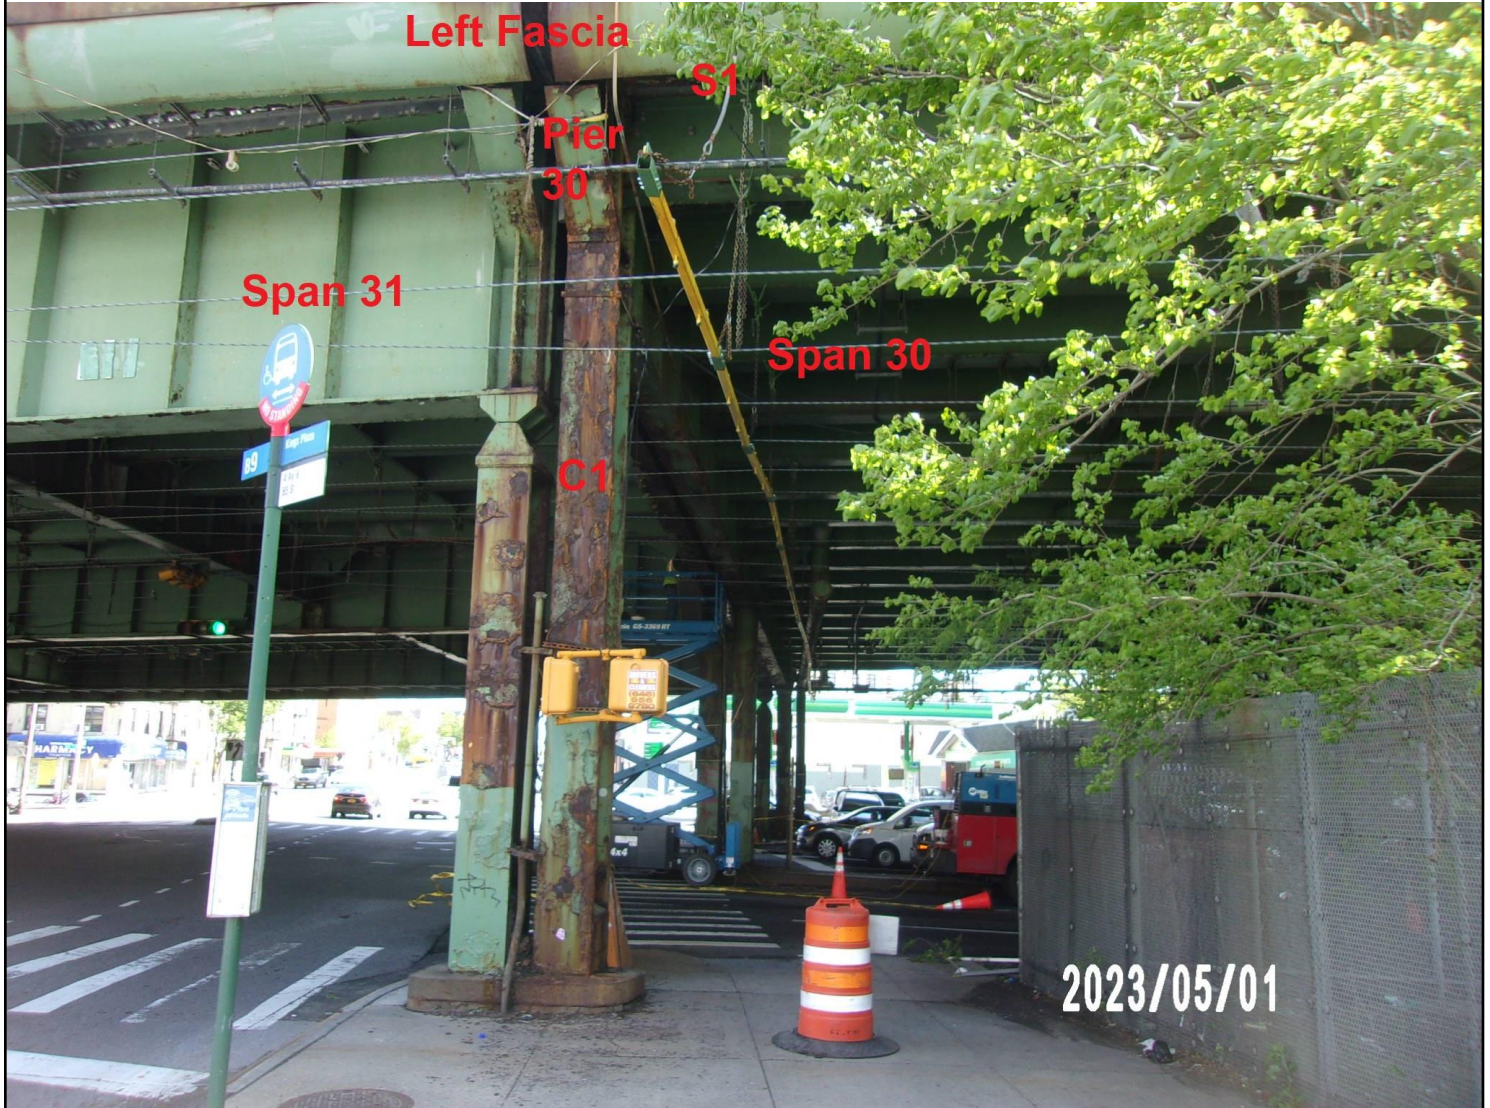
Photo Number: 5

3. Due to the access restrictions from cables in place for the ongoing contractor platform installation in Span 30, the stringer location was access with 30ft bucket truck parked on the sidewalk at the intersection of 65th Street and 4th Avenue. (Photo #5)

Attachment Description: The left side of Stringer S1 in Span 30 at Pier 30. The flagged condition at the stringer is located above Column C1 and the sidewalk at the intersection of 65th Street and 4th Avenue. Also, there were access restrictions for the stringer due to the cables in place for the ongoing contractor platform installation in Span 30. Looking Right.

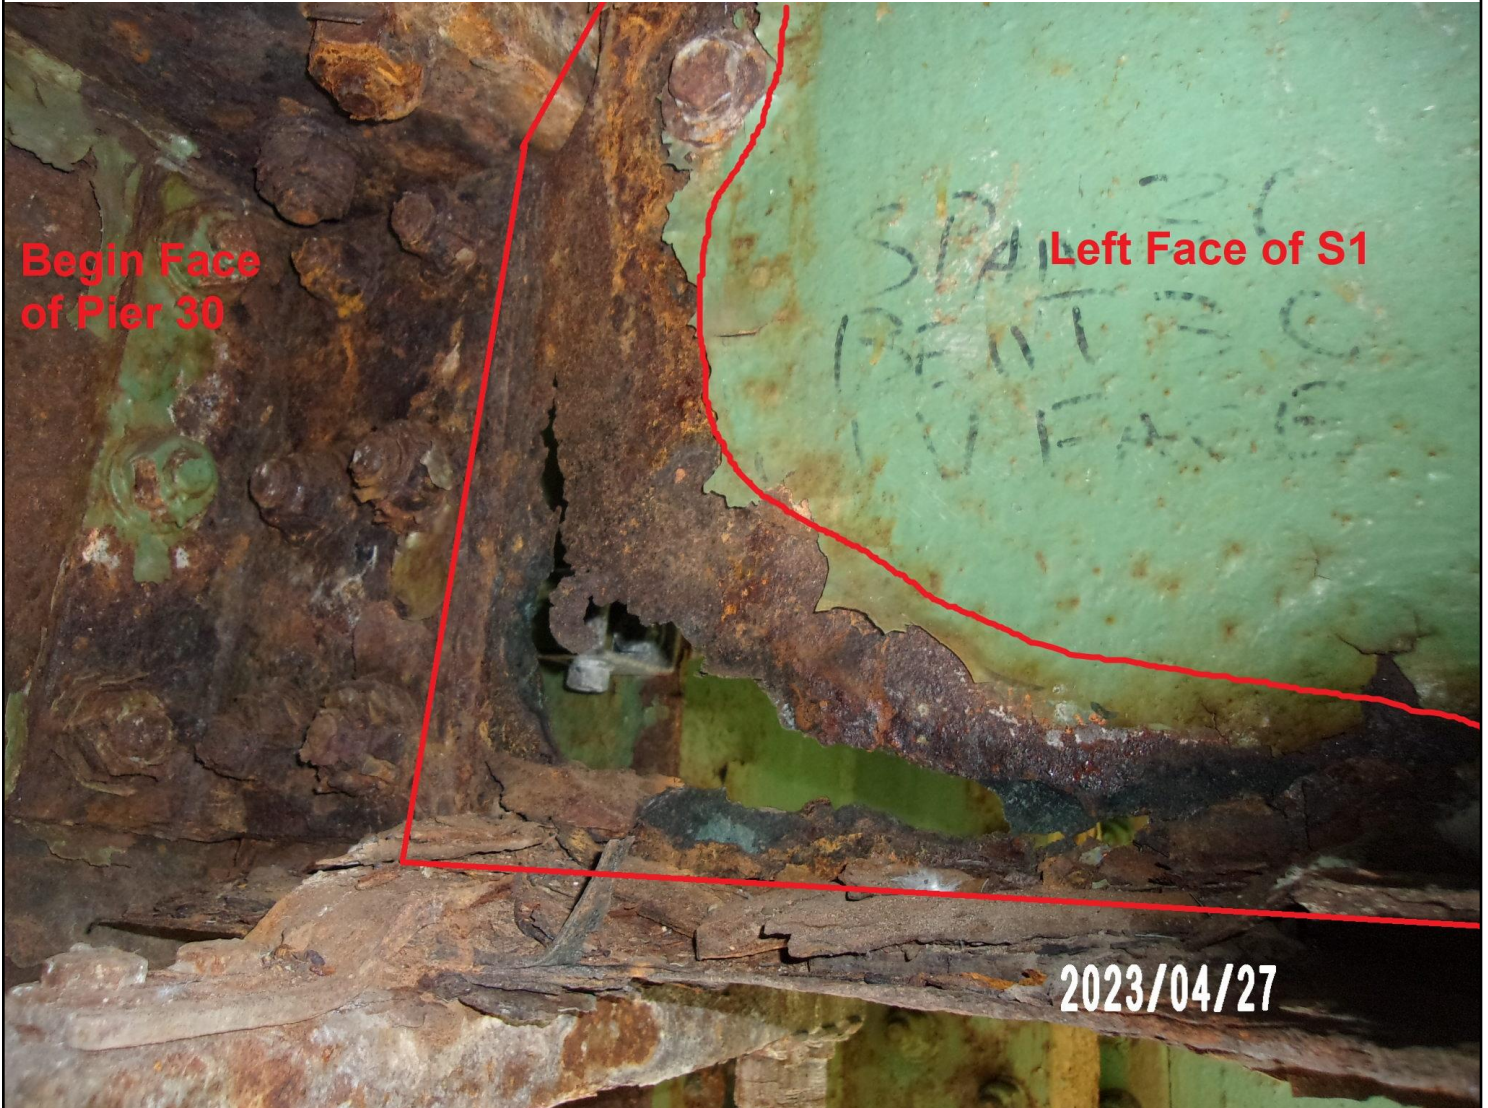
Photo Number: 6

Attachment Description: The left face of Stringer S1 in Span 30 at Pier 30. The stringer web exhibits 55% to 70% section loss for the full web height along the connection angle. The lower web exhibits a corrosion hole for 1"-9"H and up to 10"L adjacent to the connection angle with 55% section loss surrounding the hole. Looking Right.

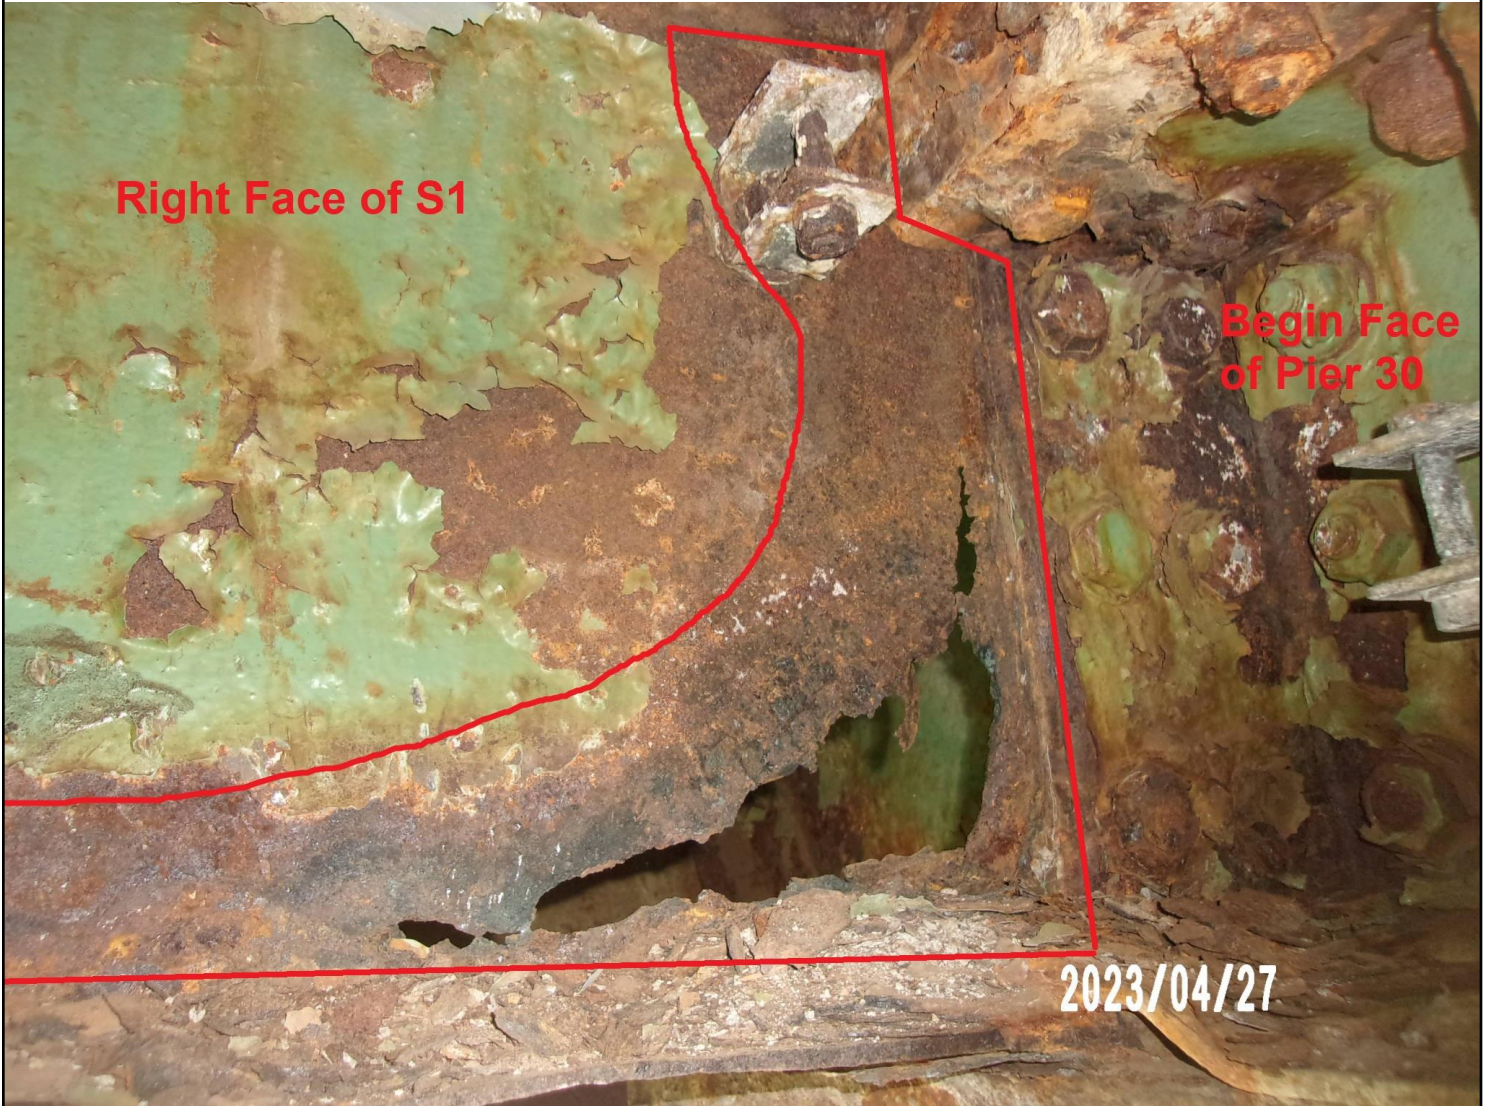
Photo Number: 7

Attachment Description: The right face of Stringer S1 in Span 30 at Pier 30. The stringer web exhibits 55% to 70% section loss for the full web height along the connection angle. The lower web exhibits a corrosion hole for 1"-9"H and up to 10"L adjacent to the connection angle with 55% section loss surrounding the hole. Looking Left.

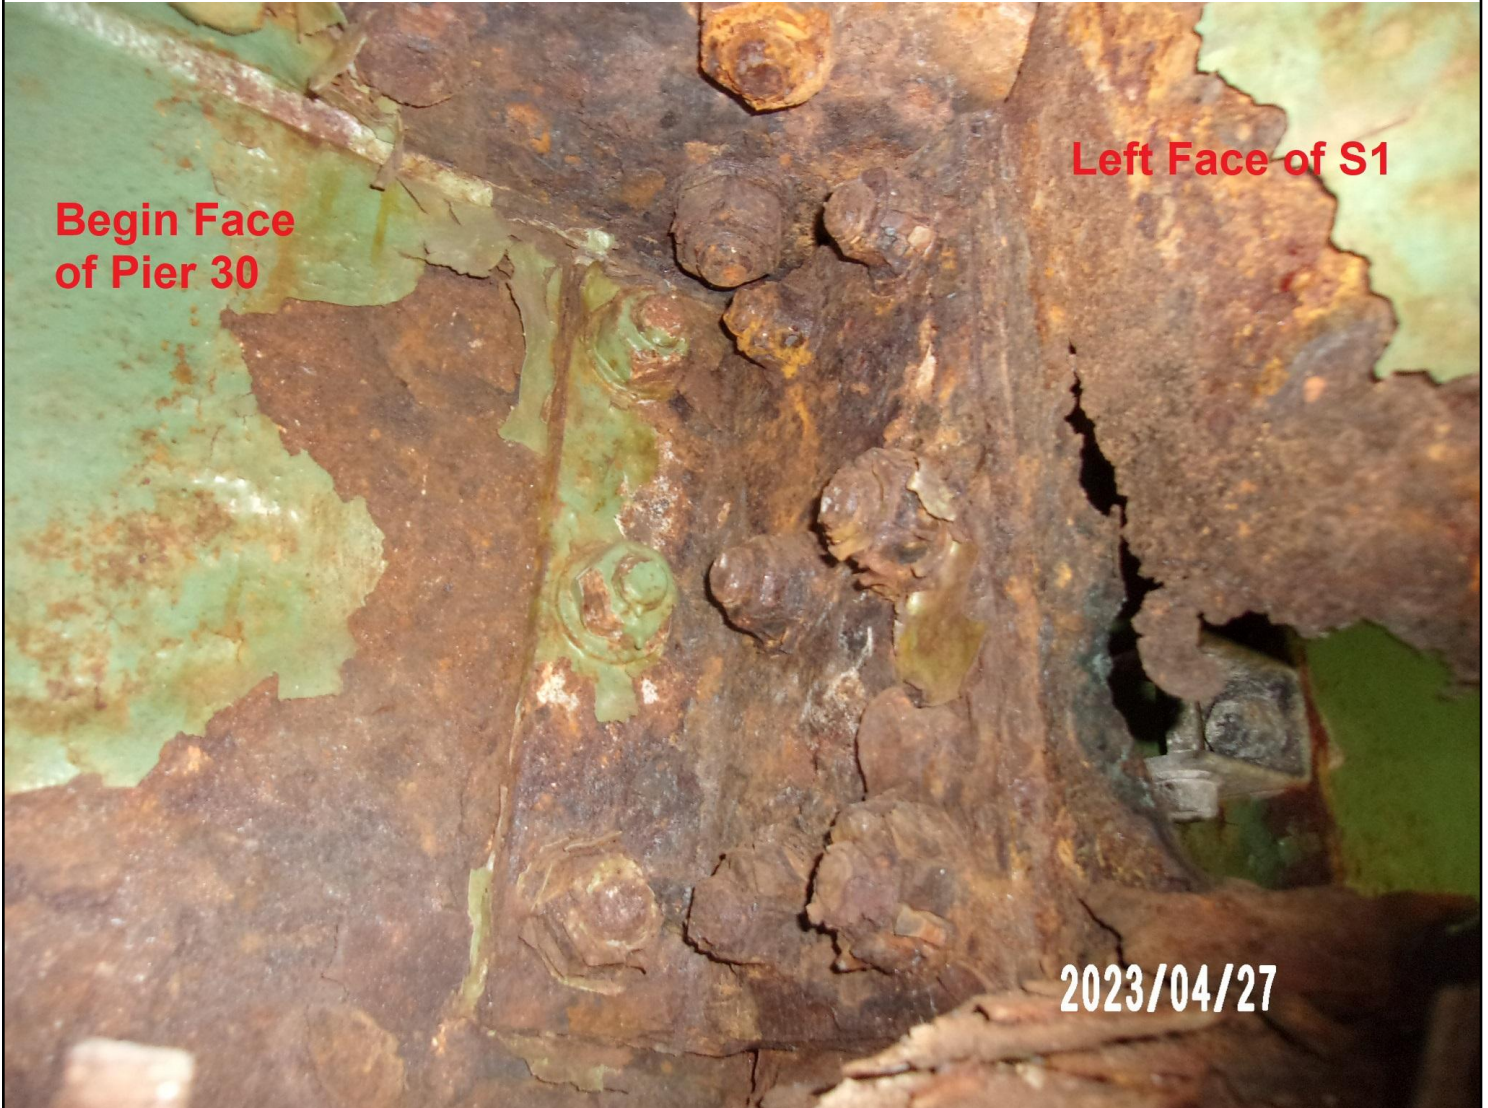
Photo Number: 8

The end of Stringer S1 exhibits severe section loss in the stringer web with 0.12" to 0.18" remaining thickness measured (RTM), resulting in approximately 55% to 70% section loss, for the full web height along the connection angle for 4"-6" wide. The overall shear web section loss is approximately 80%. The lower web above the bottom flange exhibits a corrosion hole for 1"-9"H and up to 10"L adjacent to the connection angle with section loss surrounding the hole for 9"L x 4"H with 0.18" RTM, resulting in approximately 55% section loss. (Photos #6 and #7) The bottom flange exhibits severe section loss with 1/8" to 3/16" RTM for 18"L for the full flange width at both leg, resulting in approximately 63% to 75% section loss, with two corrosion holes at the left edge of the bottom flange for 2" diameter and 3"L x 2"W and one corrosion at the right edge of the bottom flange for 1" diameter (Photo #9). Both connection angles exhibit heavy corrosion with 20%-30% section loss for the full height of the connection angles (Photo #8). (refer to Yellow Flag Condition Sketch #2 for more details).

Attachment Description: The right face of Stringer S1 in Span 30 at Pier 30. The connection angle exhibits heavy corrosion with 20%-30% section loss for the full height of the connection angle. Looking End and Left.

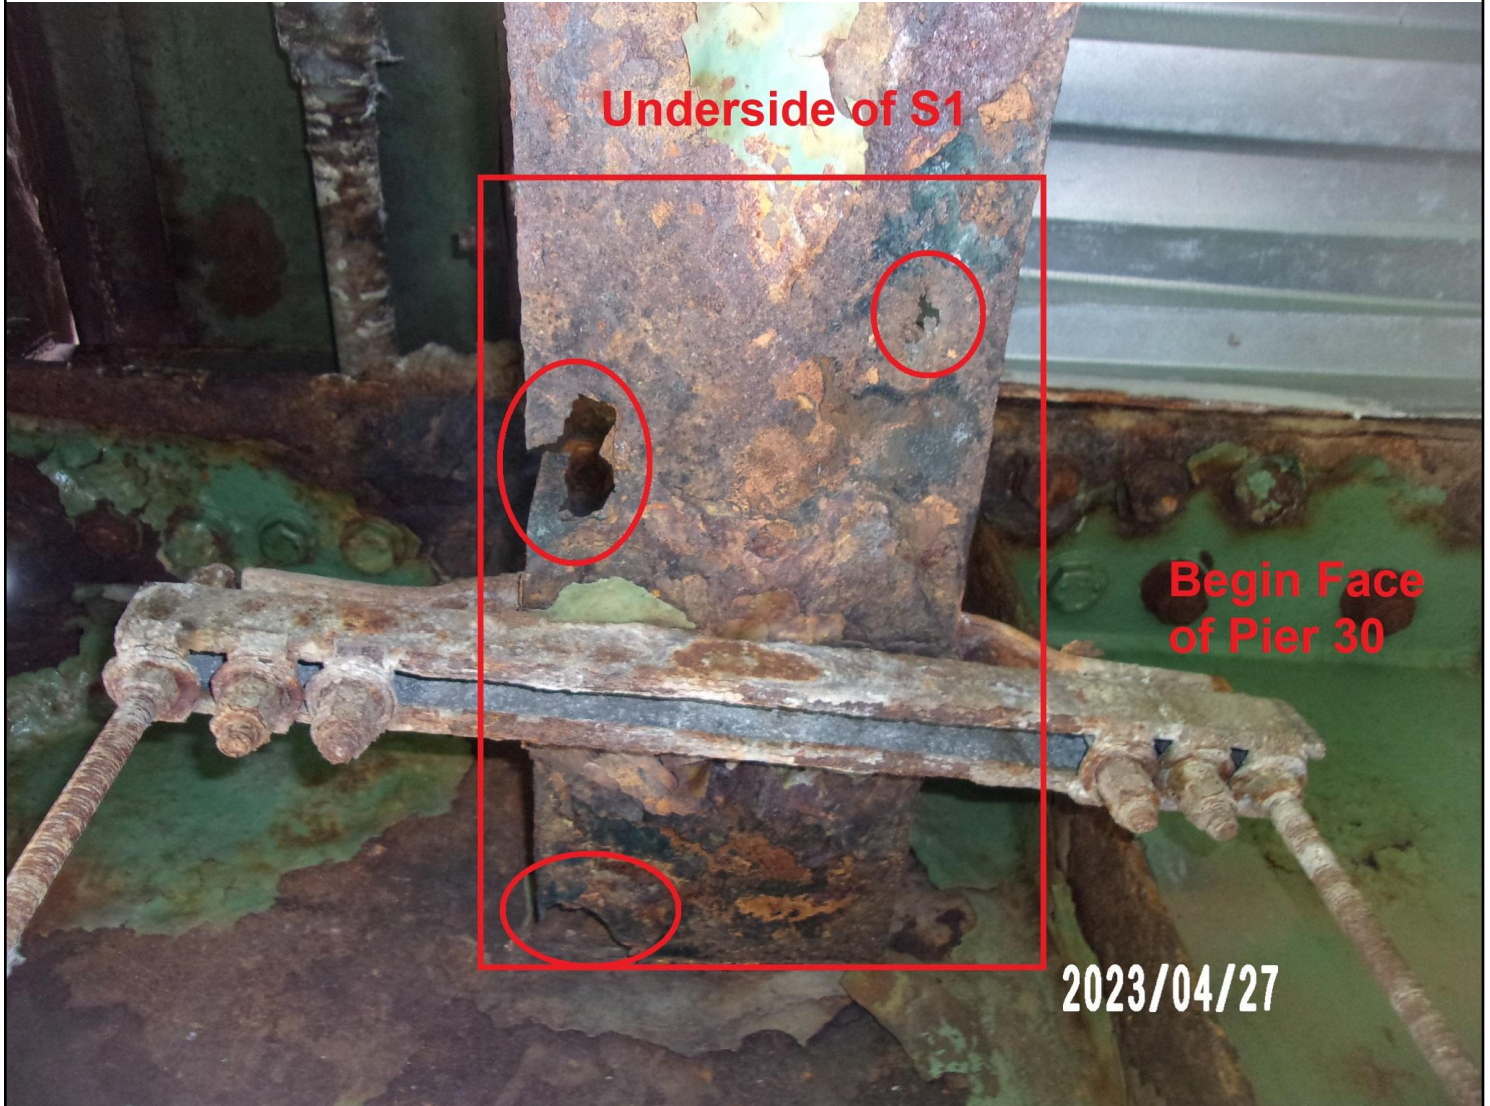
Photo Number: 9

Attachment Description: The underside of Stringer S1 in Span 30 at Pier 30. The bottom flange exhibits 55% to 75% section loss for the full flange width at both legs with two corrosion holes at the left edge of the bottom flange for 2" diameter and 3"L x 2"W and one corrosion at the right edge of the bottom flange for 1" diameter. Looking End.
